Dames & Moore Project No. 05644-081
Exploration Trench Activities and Findings
Northern States Power, Ashland, Wisconsin facility

Dames & Moore has prepared this letter to present the findings of two exploration trenches excavated on the NSP property on Friday March 13, 1998. These trenches were excavated for the purpose of attempting to locate an alleged subsurface conveyance pipe. A site map showing the location of both trenches and a photo log documenting site activities are included as attachments.

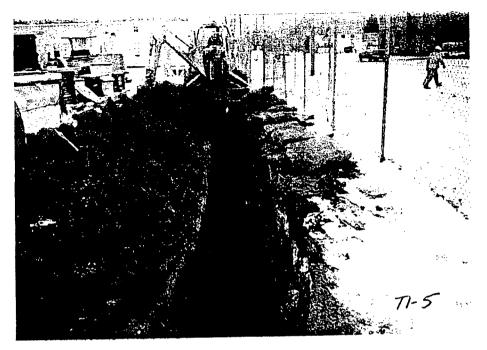
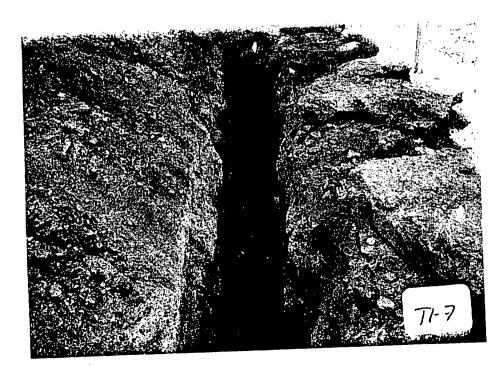
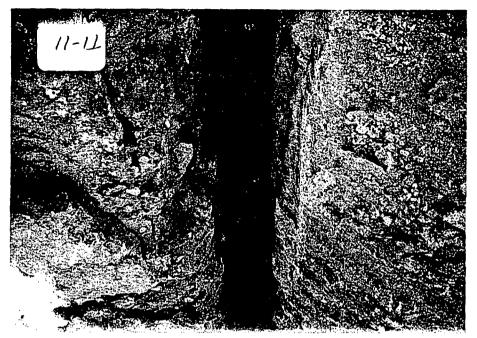
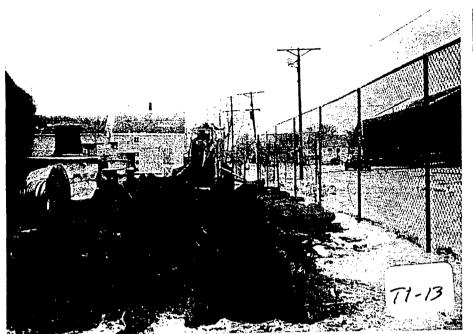
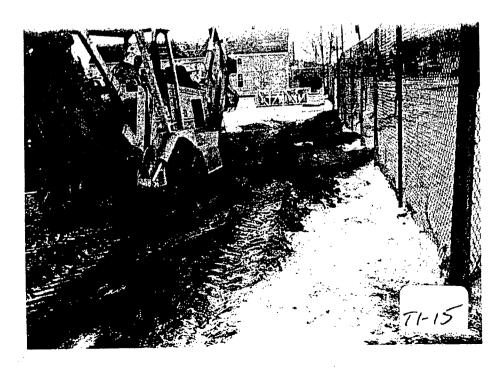
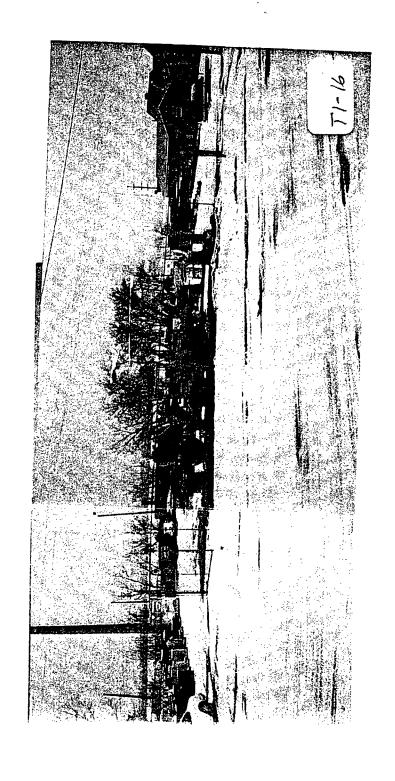
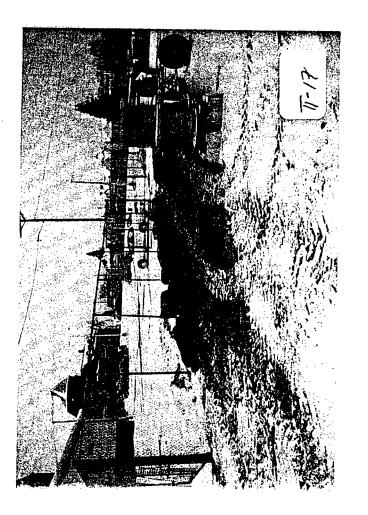
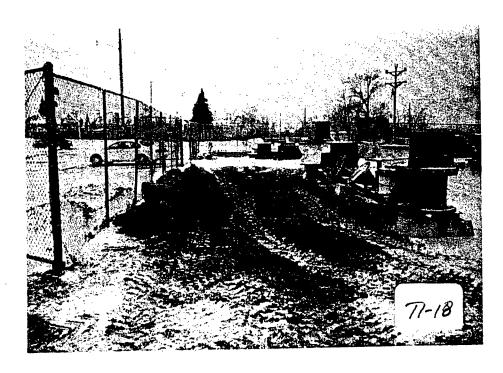
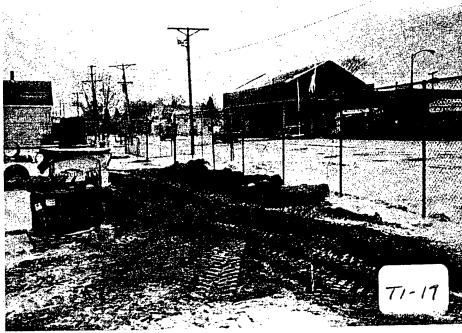
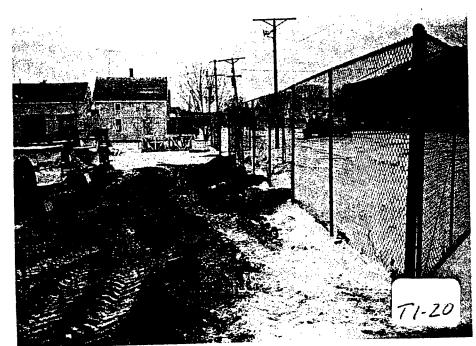
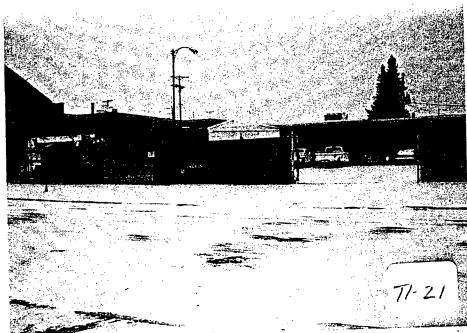
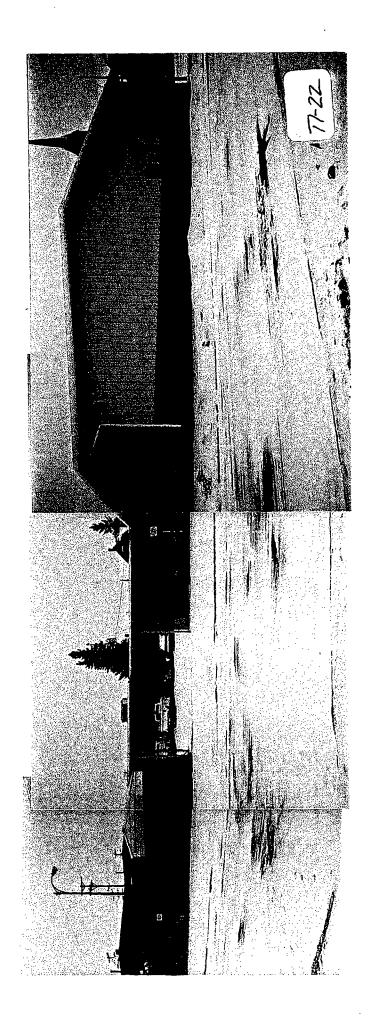
TRÈNCH 1 - PHOTO LOG

PHOTO NO.	DESCRIPTION
T1-1	Cutting through frost layer with trencher. Trench 1 area north of fence parallel to St. Claire Street.
T1-2	Trench 1 shallow trenches excavated to break through frost layer.
T1-3	Fill material encountered in Trench 1.
T1-4	Horizontal dark fill layers in Trench 1 sidewall.
T1-5	Location of Trench 1 north of NSP storage yard fence.
T1-6	Location of Trench 1 north of NSP storage yard fence.
T1-7	Fill material encountered in Trench 1.
T1-8	Horizontal fill layers (dark colored) in sidewall of Trench 1.
T1-9	Fill material encountered in Trench 1.
T1-10	Frozen blocks of surface soil from Trench 1.
T1-11	Fill material encountered in Trench 1.
T1-12	Trench 1 completed to five feet.
T1-13	Excavating on east end Trench 1.
T1-14	Fill material (reddish brown silty clay and dark fill layers) on east end of Trench 1.

PHOTO NO.	DESCRIPTION
T1-15	Regrading backfilled Trench 1.
T1-16	Backfilled and regrading Trench 1 (looking north).
T1-17	Trench 1 looking west (backfilled).
T1-18	Trench 1 looking west (backfilled).
T1-19	Trench 1 looking east (backfilled).
T1-20	Trench 1 looking east (backfilled).
T1-21	Southern parcel of NSP property.
T1-22	Southern parcel of NSP property.

Prior to the excavation of each trench, the NSP crew cut through the frost layer by cutting two shallow trenches 10 to 12-inches deep along the proposed trench. A backhoe was then used to move blocks of frozen soil, and for excavating the trench. Each trench was excavated to a depth of five feet. Excavated material was temporarily stockpiled adjacent to the trench. After the sidewalls of each trench were inspected, excavated material was returned to each trench, and the area was regraded. NSP will likely place gravel over the excavated areas later this spring. A photo log showing excavation activities is included as Appendix A.
